DEVELOPMENT OF IMPROVED HIGH
PRESSURE TURBINE OUTER GAS PATH
SEAL COMPONENTS

UNITED TECHNOLOGIES CORPORATION
Pratt & Whitney Aircraft Group
Commercial Products Division

(NASA-CR-159801) DEVELOPMENT OF IMPROVED
HIGH PRESSURE TURBINE OUTER GAS PATH SEAL
COMPONENTS Progress Report, Dec. 1976 -
Oct. 1979 (Pratt and Whitney Aircraft Group)
80 p HC A05/MF A01

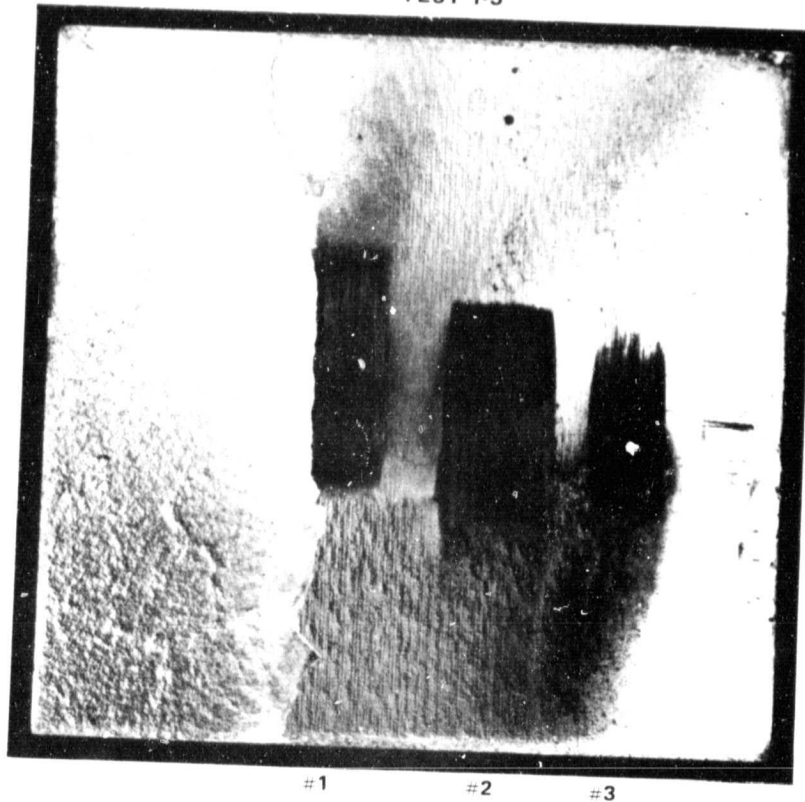
TEST 1-3

Figure 10 Abradability Tests Results - Post Test Condition

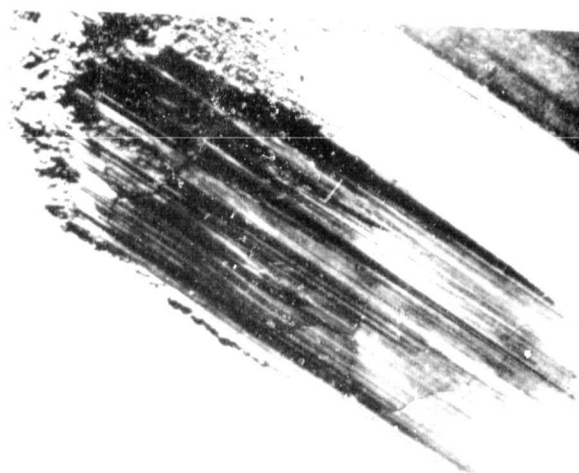
TEST 3

Figure 32 Abradability Test Results of the Improved Design - Post Test Condition

Three abrasability tests were conducted at the same conditions used to evaluate the initial design. Tests were conducted at 304.8 m/sec (1000 ft/sec) rate speed with incursion rates of 0.00254, 0.0254, and 0.254 mm/sec (0.0001, 0.001 and 0.010 in/sec). Results are presented in Table 3. Also shown in Table 3 for comparison purposes are the results of testing of the initial design. The data shows the same trend with the least blade wear at the nominal or 0.0254 mm/sec (0.001 in/sec) incursion rate and greater blade wear at both slower and faster incursions. A comparison of the repeatability of the magnitude of wear at the 0.0254 mm/sec (0.001 in/sec) test is difficult because of the unusual, unexplained, wear pattern of tests #4 which was discussed earlier. Abrasability testing generally indicated performance repeatability of the sprayed ceramic seal system. Post test condition of the parts is pictured in Figure 32.

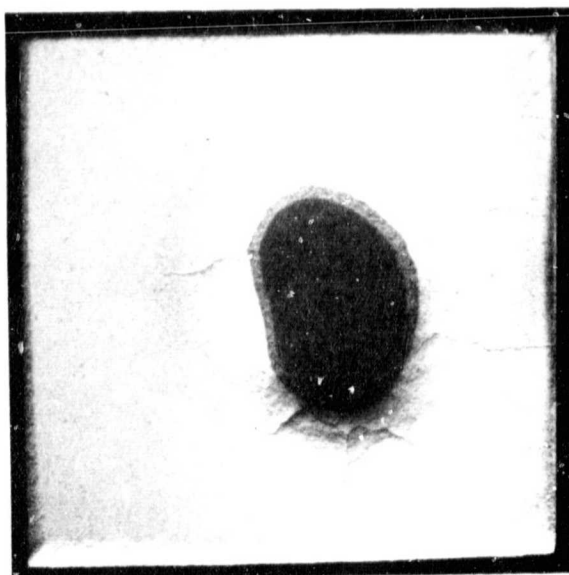
Impingement Angle = 90° (1.57 radians)

Figure 34 Erosion Test Results of Improved Design - Post Test Condition

Results of both of these tests are shown in Table 4 along with earlier erosion testing of the initial design. The particulate flow rate in these two tests was 45 gm/min, 5 times greater than that used in earlier testing. Based on the assumption that erosion rate is directly proportional to particulate flow rate test No. 1 at a 0.262 radians (15°) angle is close to a factor of 5 greater than test No. 3 indicating good correlation. An attempt at correlating results of test No. 2 and No. 5 at 1.57 radians (90°) is compromised somewhat by 1) the erosion extending into the 85/15 and 40/60 $ZrO_2/CoCrAlY$ layer and 2) the effect of particulate bounce back and collision with the impinging particles. Post test condition of the parts is shown in Figure 34.
